So today as it's a bit cooler in the "workshop" (Shed) (37 degrees) and a bit cooler in the garage about 30 degrees, I thought I would have a mad moment and fix my nearside headlamp range adjuster.

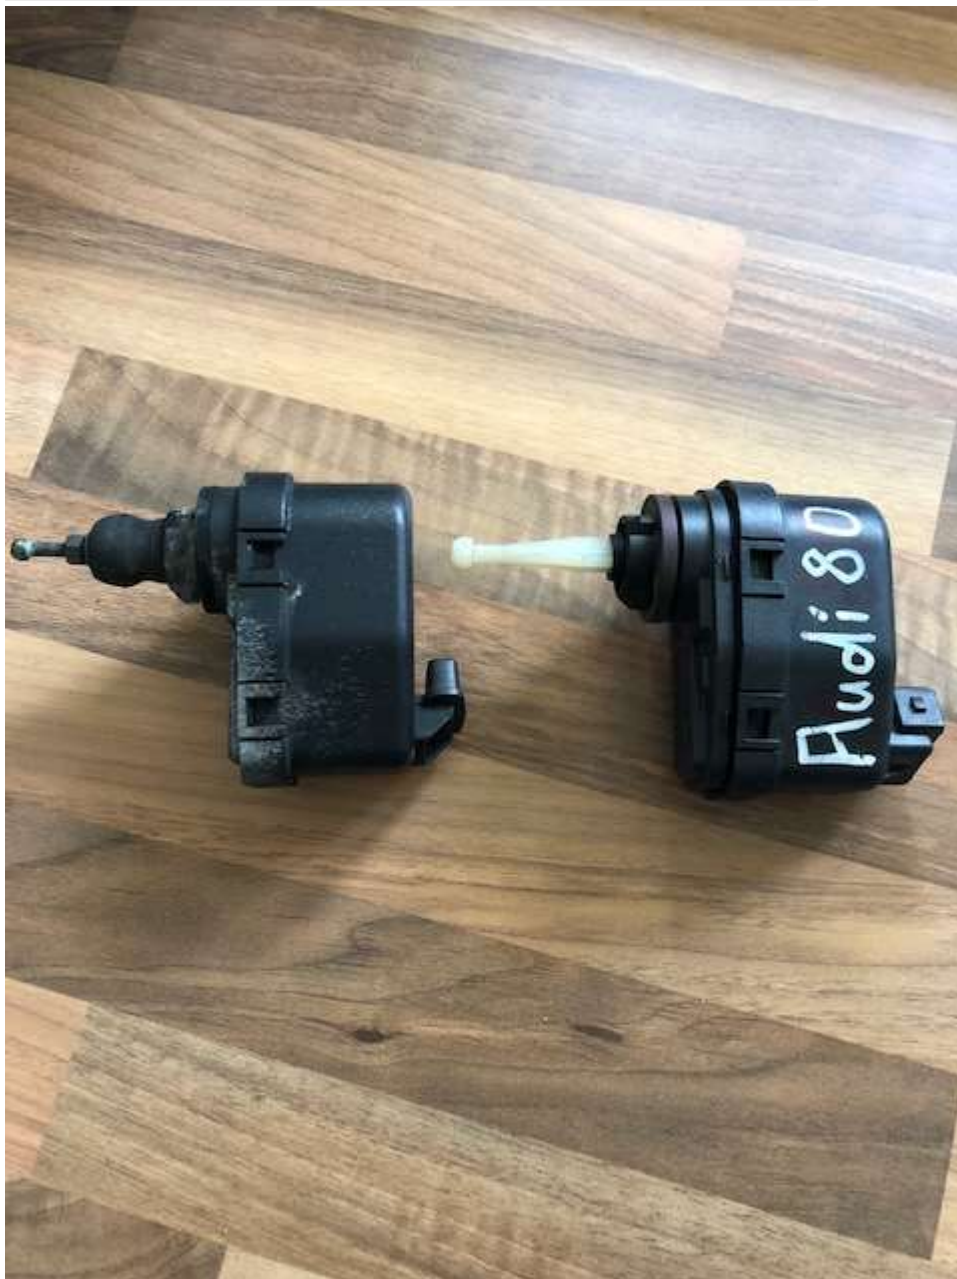
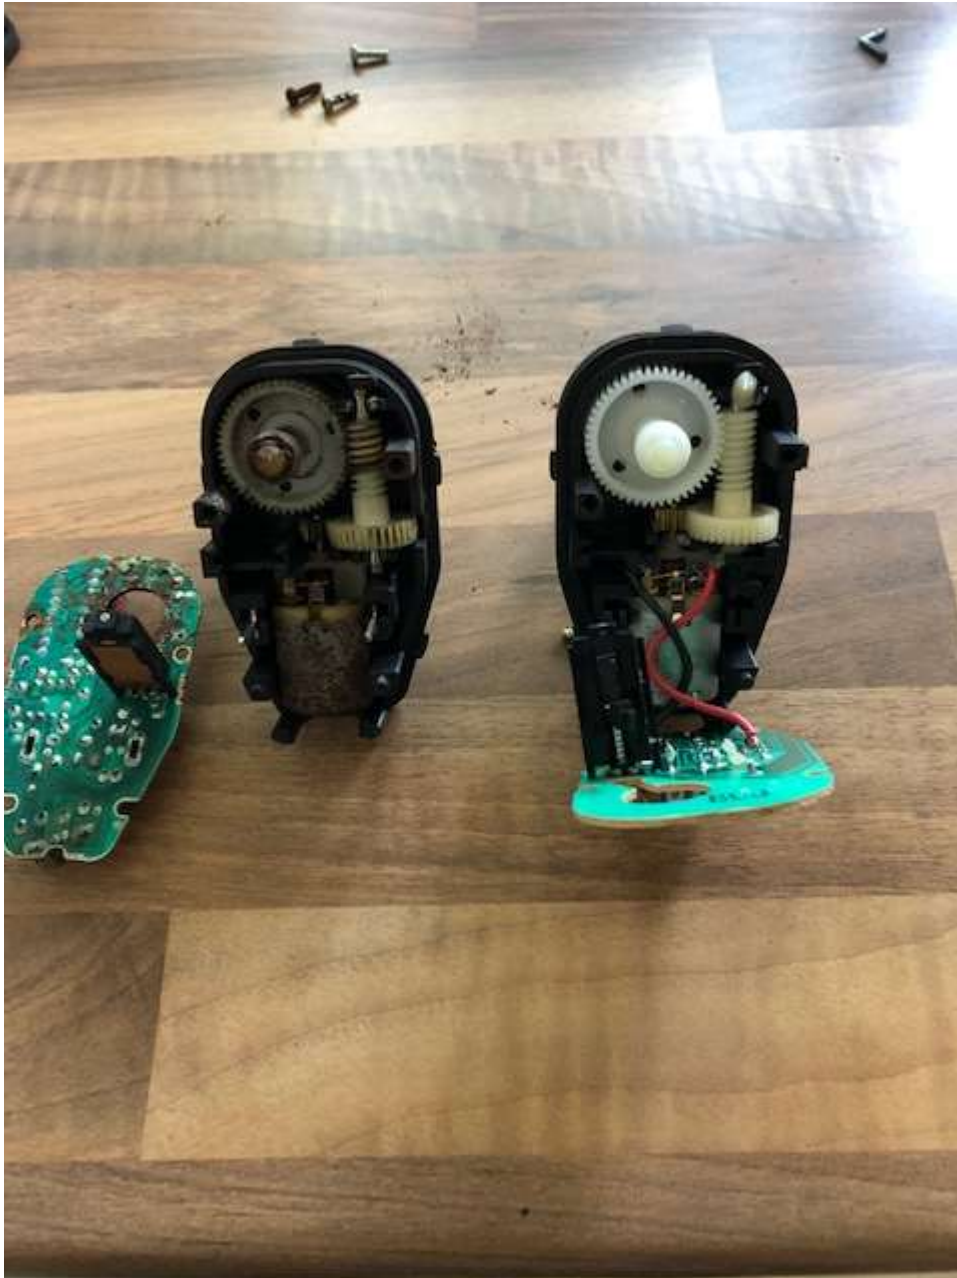
the two side by side, I really don't need to point out which is which

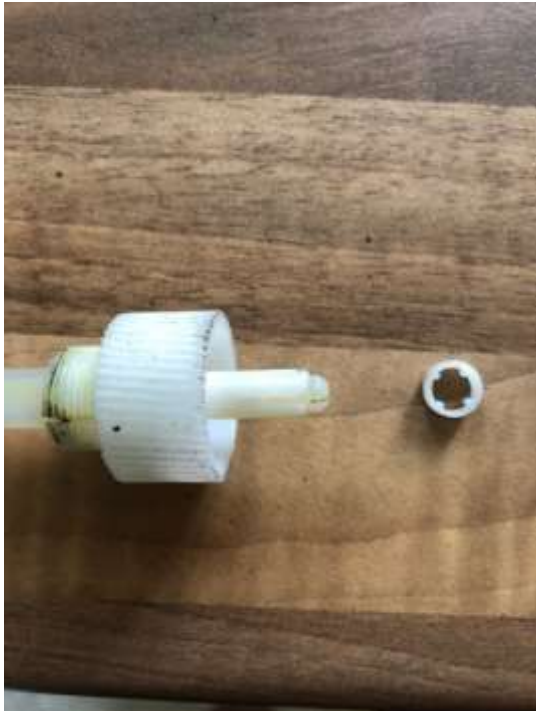
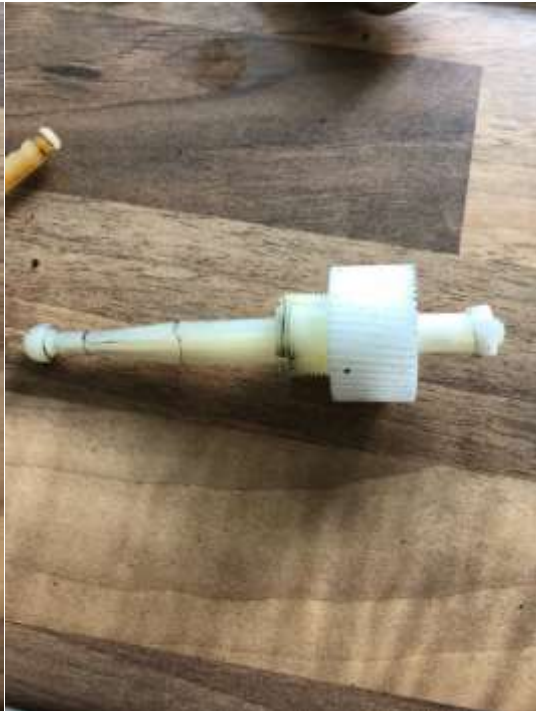
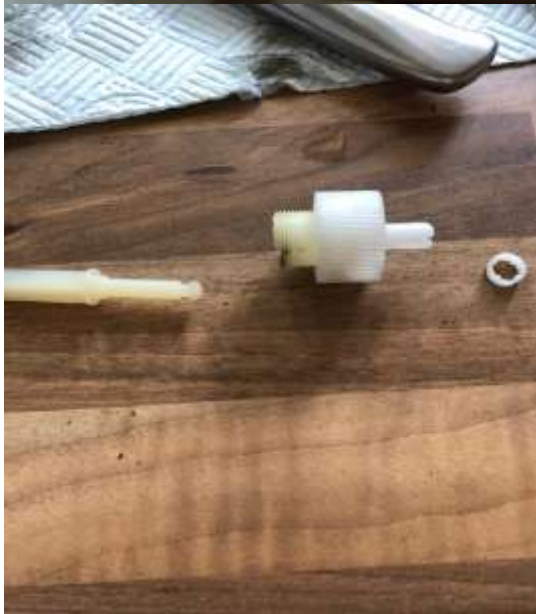
the first thing is to get the gears and push rod out of the replacement motor, you need to remove the two screws holding the board, then gently lever the board off, then the next task is to get the gears out.

as you can see in the picture above of the inside, you need to pop out the worm drive, then wind out the big round gear (LH thread), take the lock ring off the end and provide a little whack to knock out the shaft,

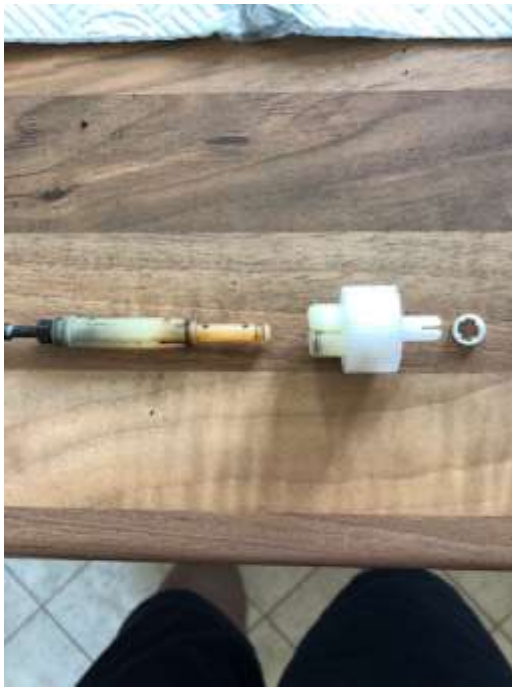
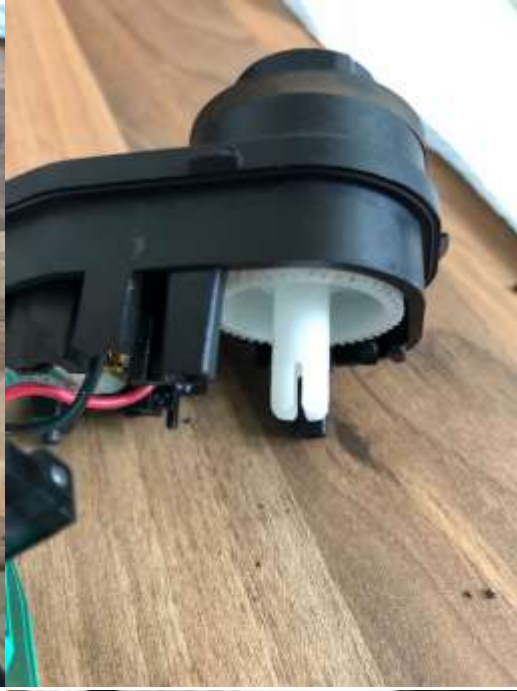
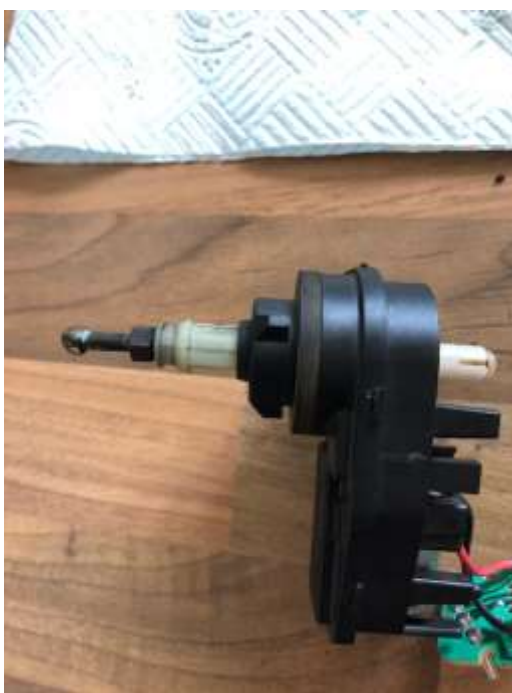
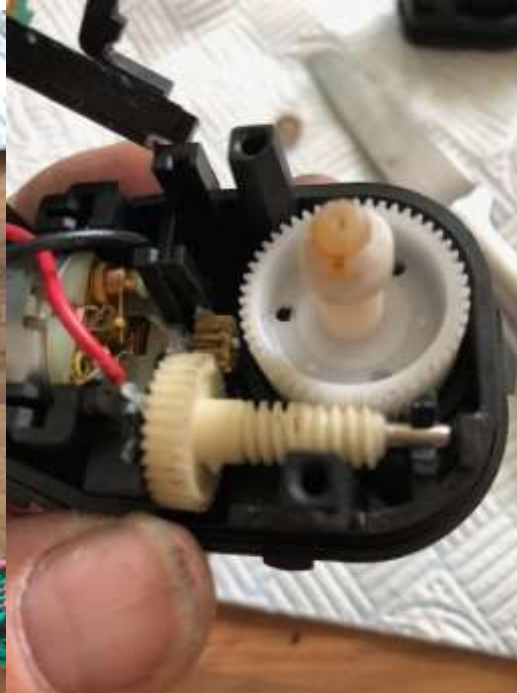
Now you need to do exactly the same to the old Porsche motor, but this time take the lock ring off then whack the shaft out leaving all the old bits in the motor case, then start to reassemble the replacement motor

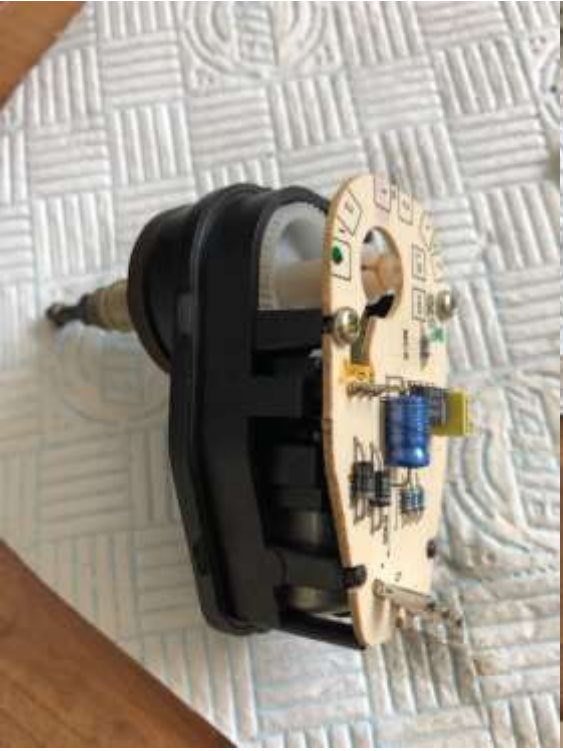
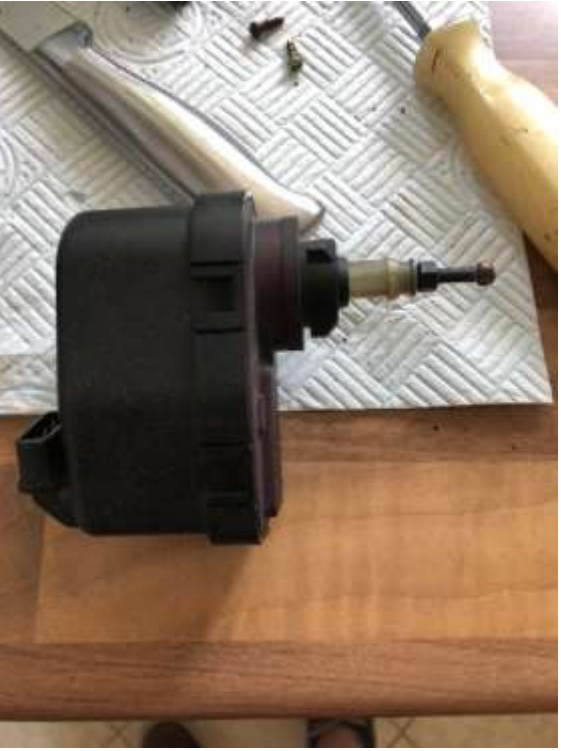
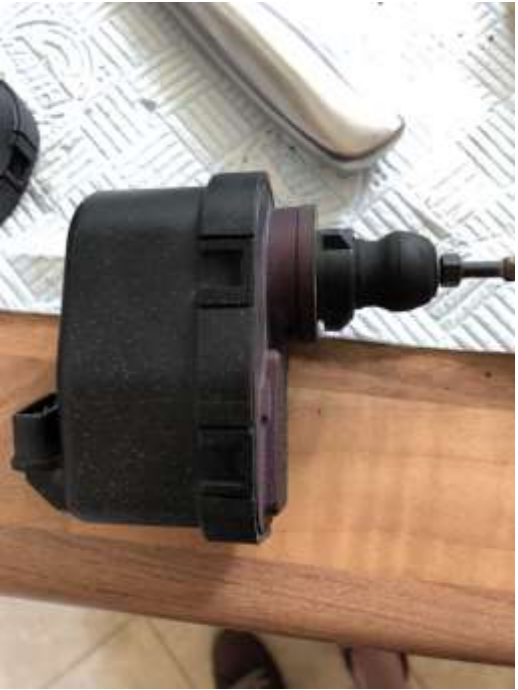
A good helping of white silicone grease is a good thing to fill this up with, I kept it clean so I could do the photos

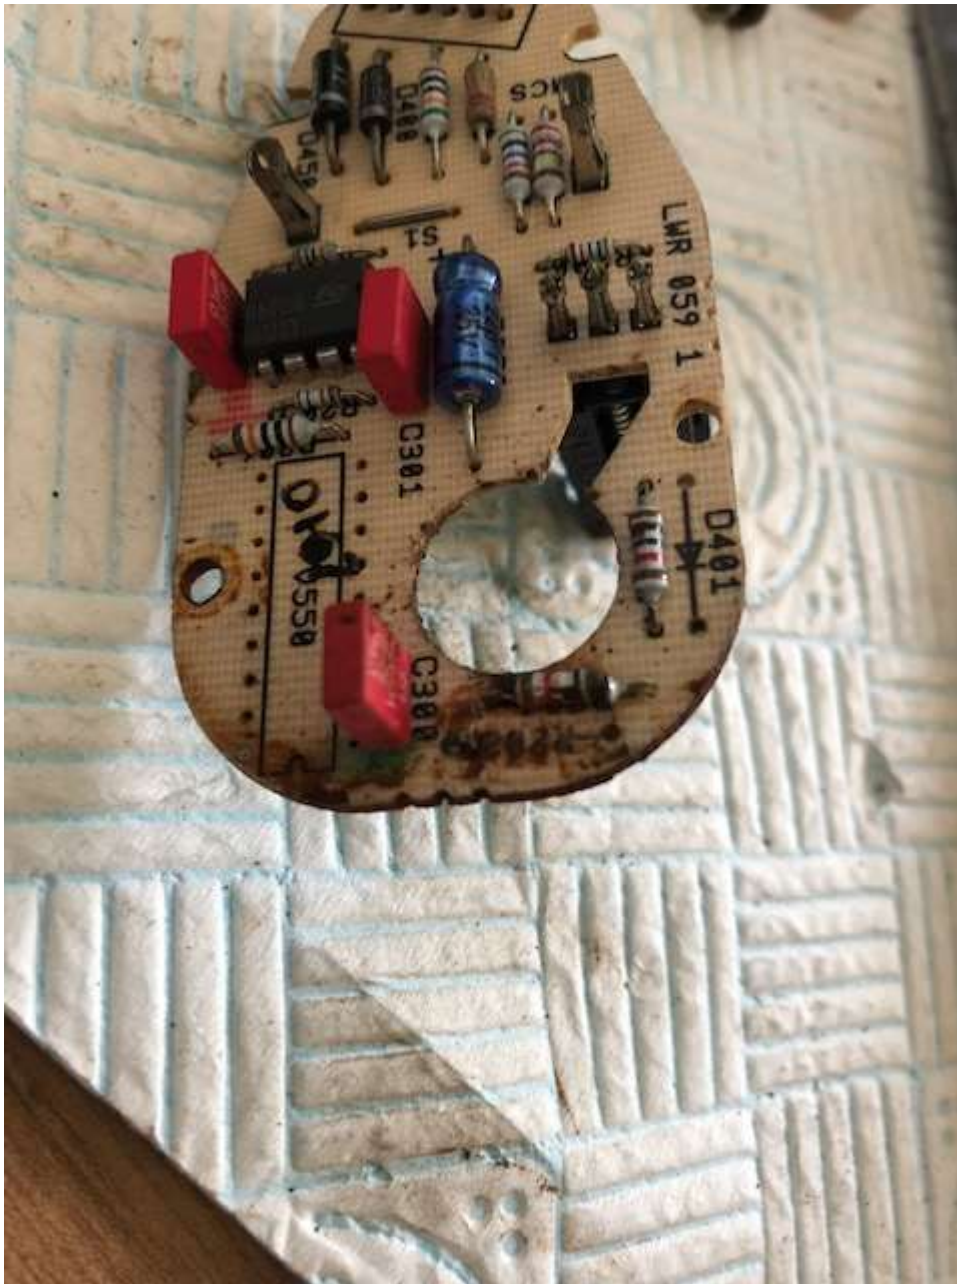
this is a close up of the old board,
